Flood Strip Out Procedure

Ambrose Construct Group Pty Ltd (ABN: 35 131 176 102)

Flood Inundation Strip Out Procedure

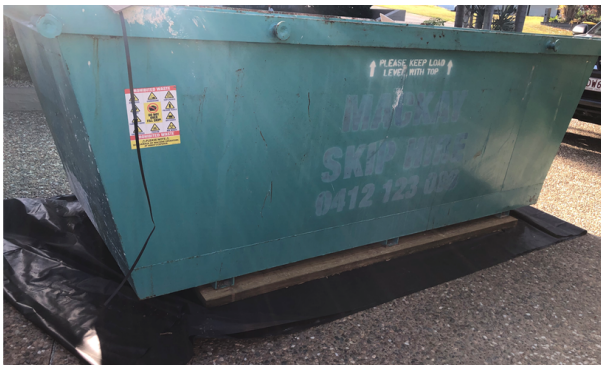
1. Ensure a skip is onsite and the driveway/ finished surfaces are protected. Pre-existing damage to be photographed/ documented.

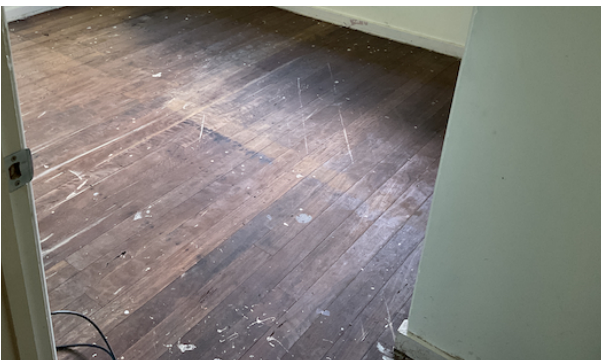
1. Photograph any pre-existing scratches /cracks/damaged to flooring/ tiles/ unaffected appliances etc.

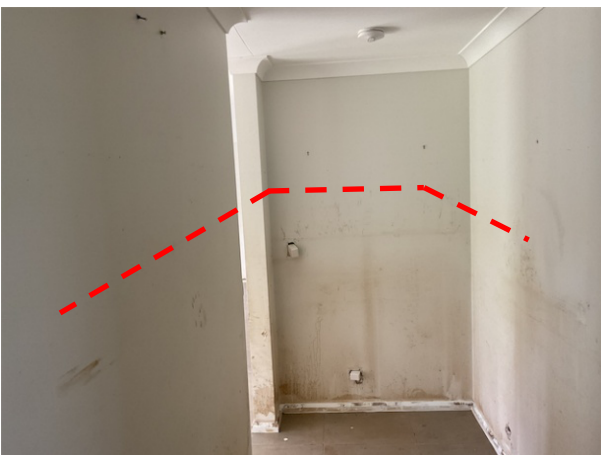
2. Photograph and measure the inundation line internally.

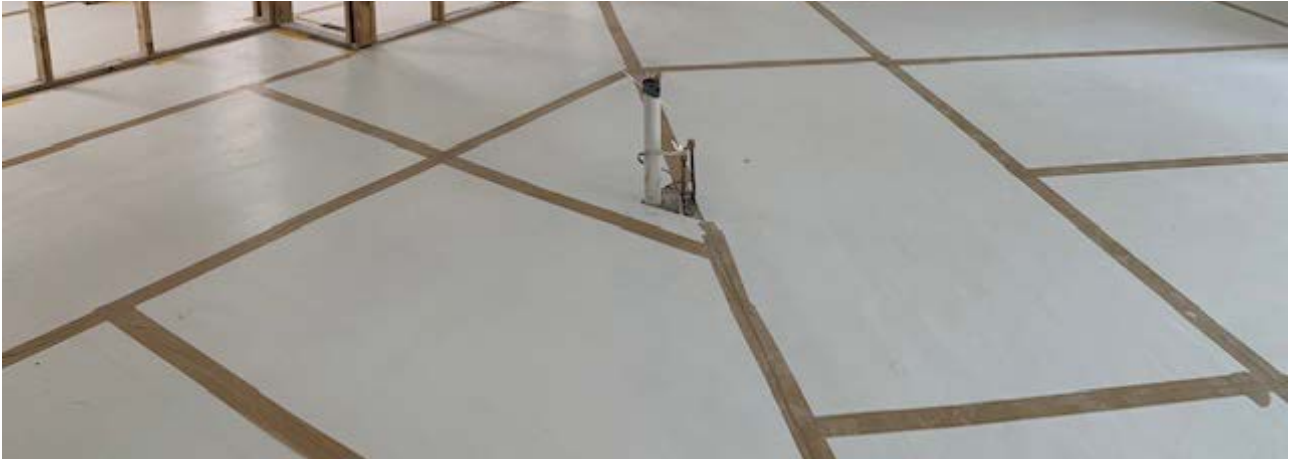
1. Ensure floors are swept clean and clear of any debris prior to installation.
2. Install floor protection to all tile and timber floors, with joints taped. Note: floor protection will need to be removed at the end of strip out to achieve PRV clearance. New floor protection will then need to be re-installed for the repair phase.

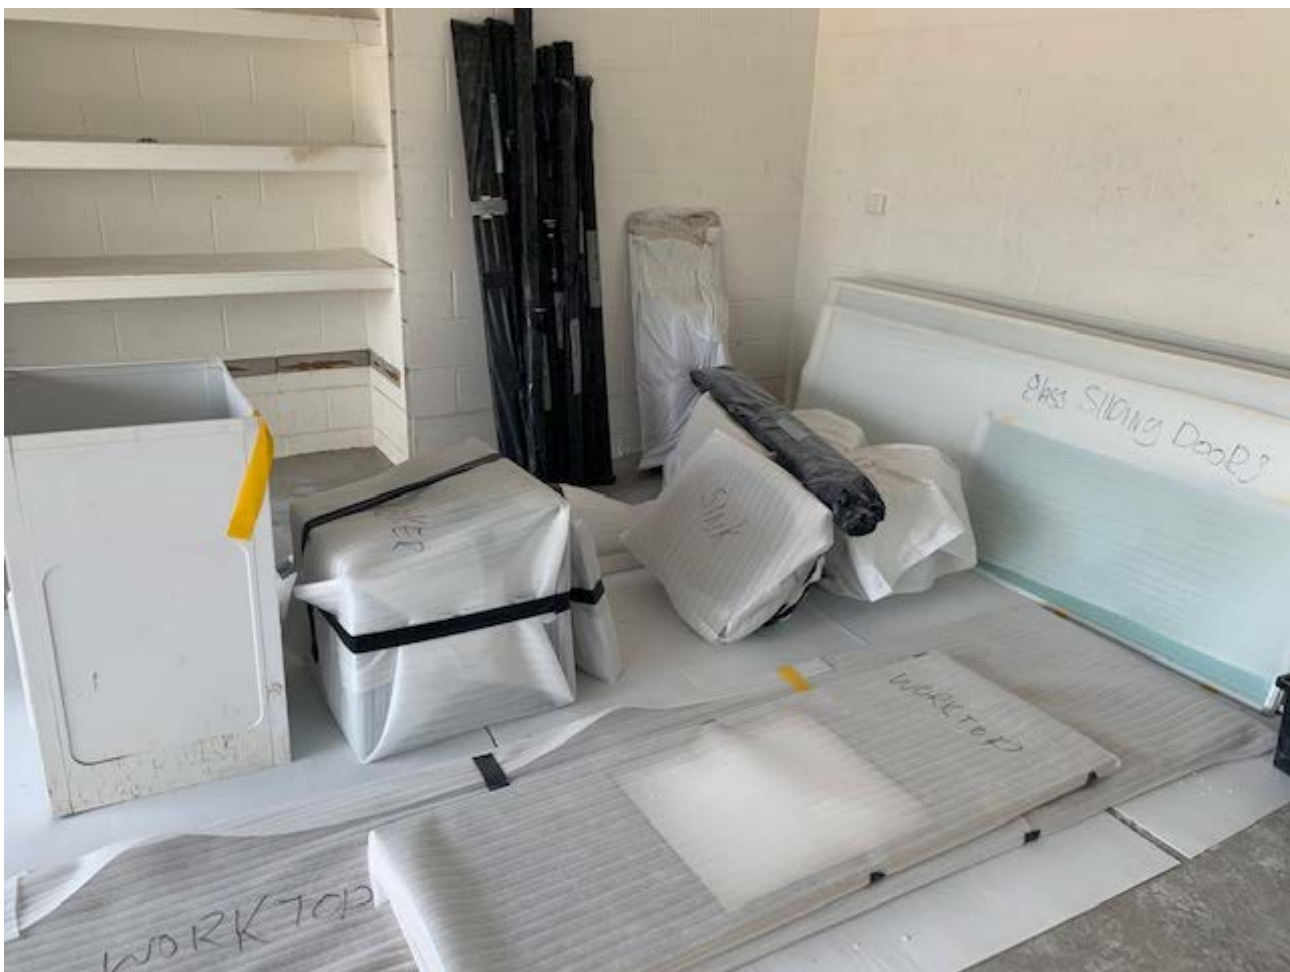
1. Remove, clean, wrap, label and store any door furniture which can be re-used. Advise in report any items not suitable for re-use.
2. Cavity slider frames and the packers under the frames to be removed.
3. Solid timber doors if not damaged or swollen may be cleaned and sanitised, PRV passed and re painted.
4. Doors that are to be re-used to be labelled and stored flat and covered to prevent bowing.
5. Timber reveal sliding external doors required have the affected material/ packing around them removed however are not required to be removed for PRV.
6. Steel Door jambs can remain in place. If there was a packer or plasterboard behind the jamb, the material behind the jamb must be removed for clearance.

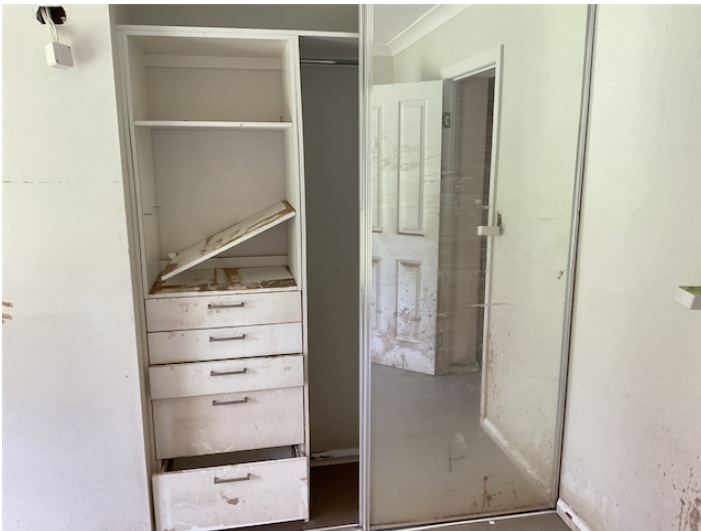
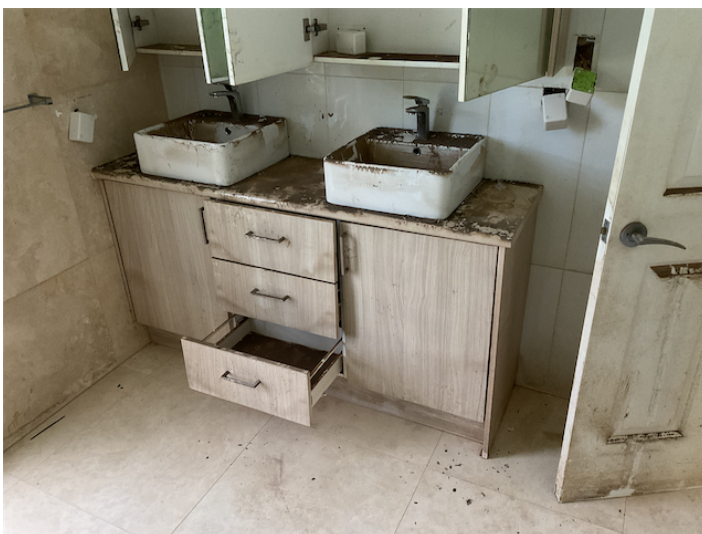
6. Photograph existing robe configurations. Remove affected shelving, drawers, gables, doors and door tracks, jambs and arches. Top shelving may be able to remain in-situ if above flood line.

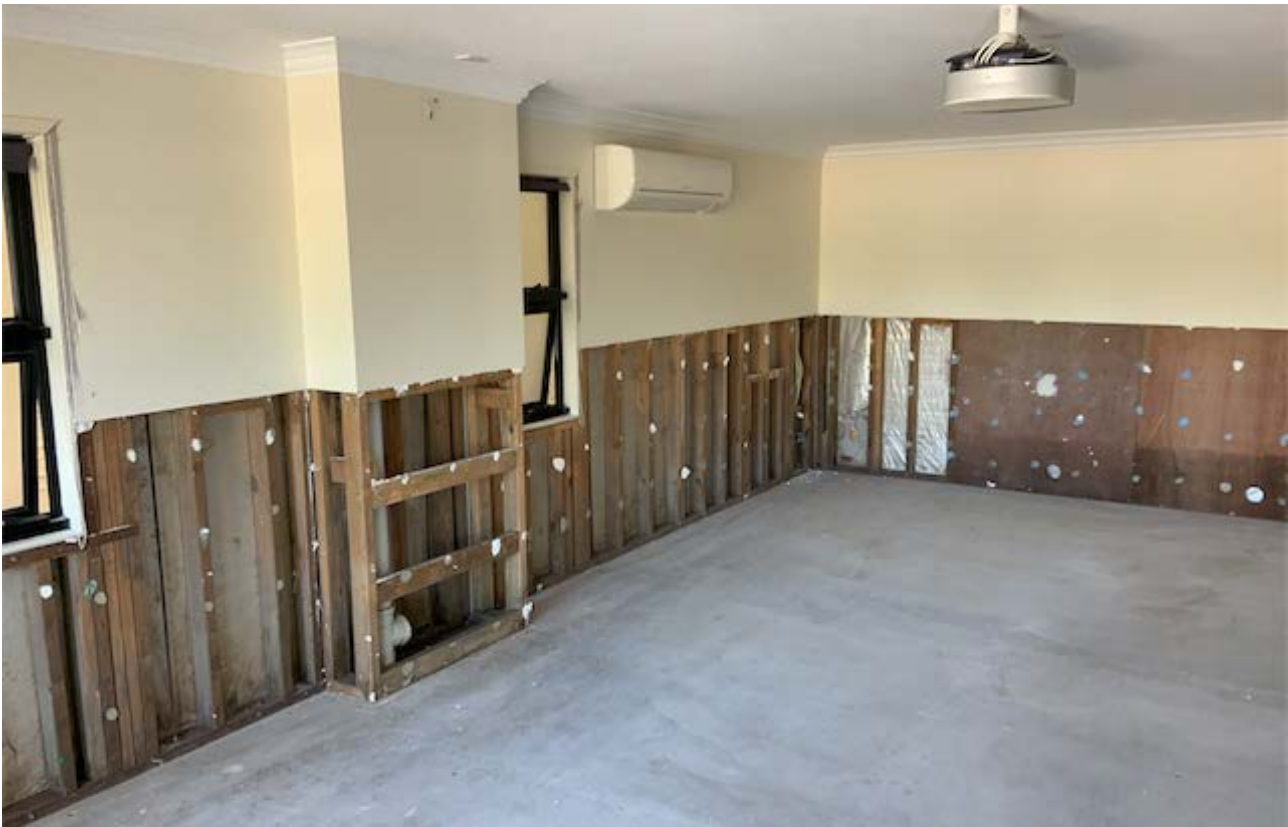
1. Strip out all water damaged wall lining to nearest sheet join above flood line.
2. Strip out ply bracing to 300mm above flood line. If more than 1200mm of bracing is removed install a temporary timber cross brace.
3. All vertically installed sheeting to be stripped full height. FC, MDF and Masonite sheet linings are commonly installed vertically and will require full height strip.

Question - What's missing on this strip out?

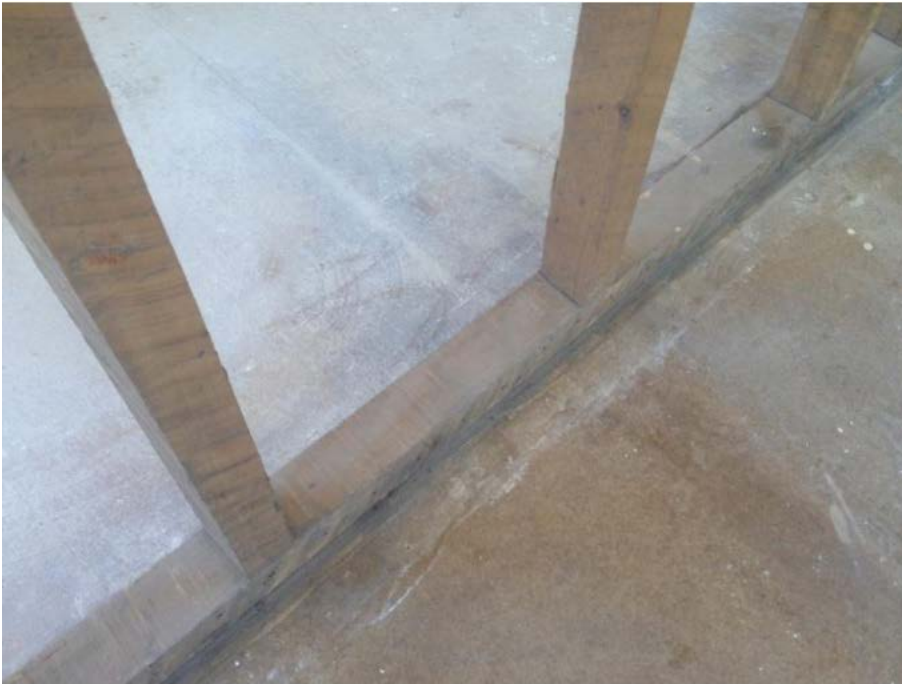
Below is an example of a properly stripped and cleaned wall frame, with no remaining screws, nails or glue.

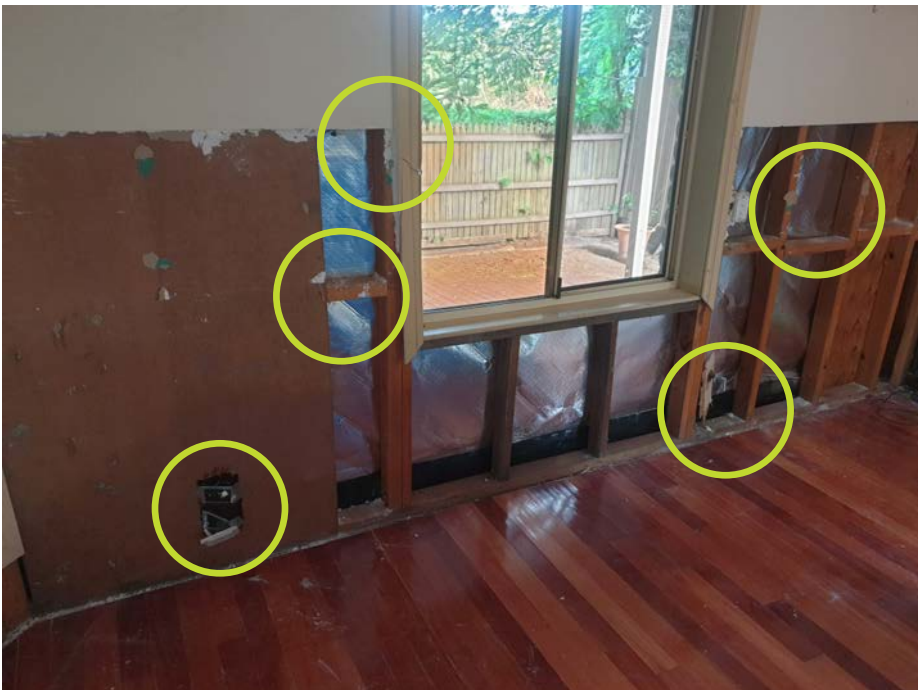
Below is an example of an **unacceptable** stripped wall frame, with screws, nails and glue remaining, joins not cleared and/or recessed and electrical items not isolated.
